## Introduction

This information sheet outlines reasonable owner expectations for an onsite sanded and finished timber floor. This includes solid T&G flooring, parquetry and other flooring types that have been sanded and finished onsite or recoated. Concerning this, there are performance aspects of the floor which generally relate to fixing integrity, board shape and movement, and then there are appearance aspects which focus more on the sanding and finishing.

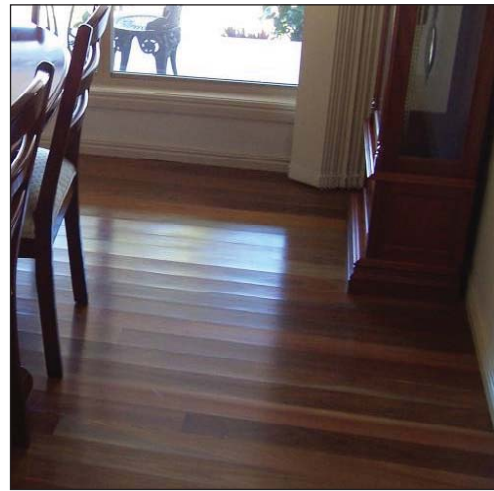
*Observable peaking*

**Peaking** – This has the appearance of cupping but is the result of expansion pressure in the floor. Again it is generally expected that a floor would be free of observable peaking.

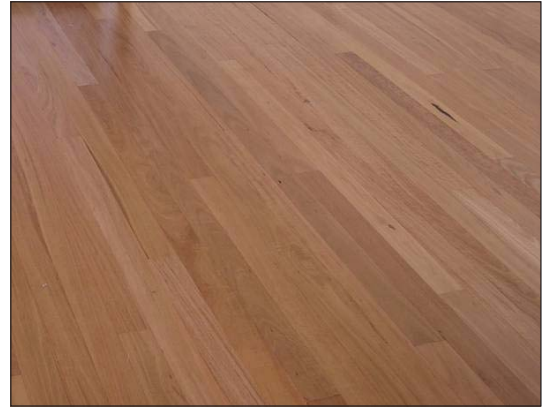
*A select grade Blackbutt floor where the backsawn gum vein toward the top right exceeds grade limits but is acceptable within the floor.*

Within a single species the colours and colour variation can be quite pronounced and can differ markedly from one floor to another. It is also possible that a limited number of boards of different species but similar in colour and character will be present in some floors and this should not be cause for concern. Through grading errors or when a floor is sanded, it is also likely that some features will appear or be a little larger than the grade description. There is however generally a clear difference between a floor that is of the incorrect grade and a floor where grade limits have been exceeded in some boards. Such floors where the grade description is exceeded in some boards should also not be a reason for concern. Refer to ATFA Information Sheet No. 5 Floor Colour and Grade.

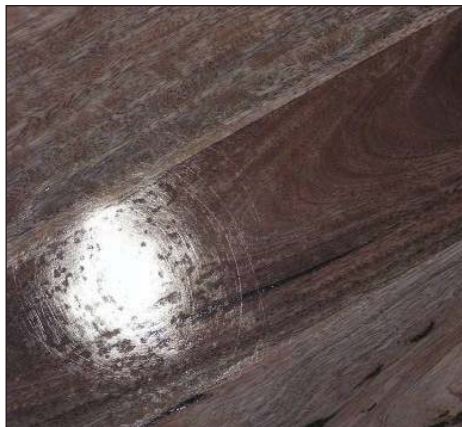
*The photo to the left shows circular swirl marks that are visible under down light. The photo to the right shows the same section of floor in natural light without the down lights on and the swirl marks are not visible.*

**Swirl marks** – Swirl marks are caused by rotary sanders and to some degree will be present in all floors. Down lights will highlight sanding imperfections due to light refraction through the coating and as such this is not controllable by the contractor. Fine swirl marks that are not obvious under natural light when assessing a floor should not be a concern.

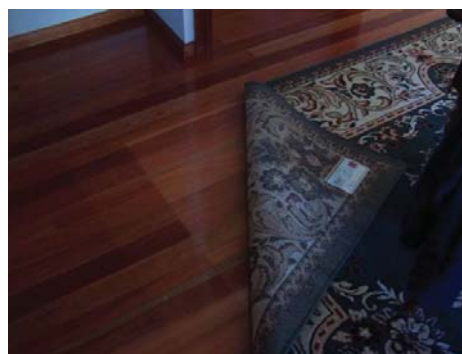
*Colour change of timber and coating beneath this floor rug.*

Over the course of time colour changes occur in timber floors from the effects of ultra violet light. Therefore it is usually more pronounced in sun exposed areas of the floor. This is partly associated with the changes in the timber and partly with the coating that is applied. Some coatings darken with time more than others and some timbers are more prone to colour changes than others. This process is natural and gradual but can result in distinct colour differences where rugs have been put on the floor. Some of this change can be minimised by not putting rugs down till six or so months after the floor has been completed. To avoid severe effects it is beneficial for flooring contractors to make clients aware of how the coating used may result in colour differences. From there it is up to the owner to manage how rugs are used.
